Manhole Inspection Summary

Manhole # S23K1_002MH

Inspection ☐ Is Incomplete Rating: **4) Poor**

Location Address: **2933 Rayshire Rd.**

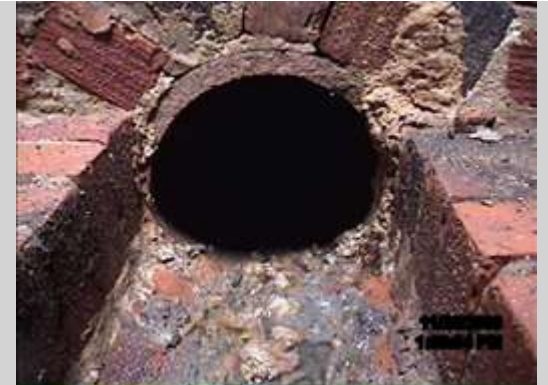
12 O'Clock Outflow

8 in. Circular Gravity Sewer
Pipe Out @ 12 O'Clock

Pipe Height: **8.4** (in.) Rod and Bar (Angled)
Pipe Material: **Clay** ☐ Pipe Lined
Invert Depth: **7.60** (ft.) Flow Characteristics: **None**
Deposits: ☒ None ☐ Mud ☐ Sludge ☐ **Debris** ☐ Grease
Silt Depth: **0** (in.) Deposits Extent:
Infiltration: **None** Pipe Seal Cond: **Sound**
